ANNUAL REPORT FOR 2011

**Phipps Creek Site #11 Mitigation Site
Yancey County
TIP No. R-2518B**

Prepared By:
Natural Environment Unit & Roadside Environmental Unit
North Carolina Department of Transportation
December 2011

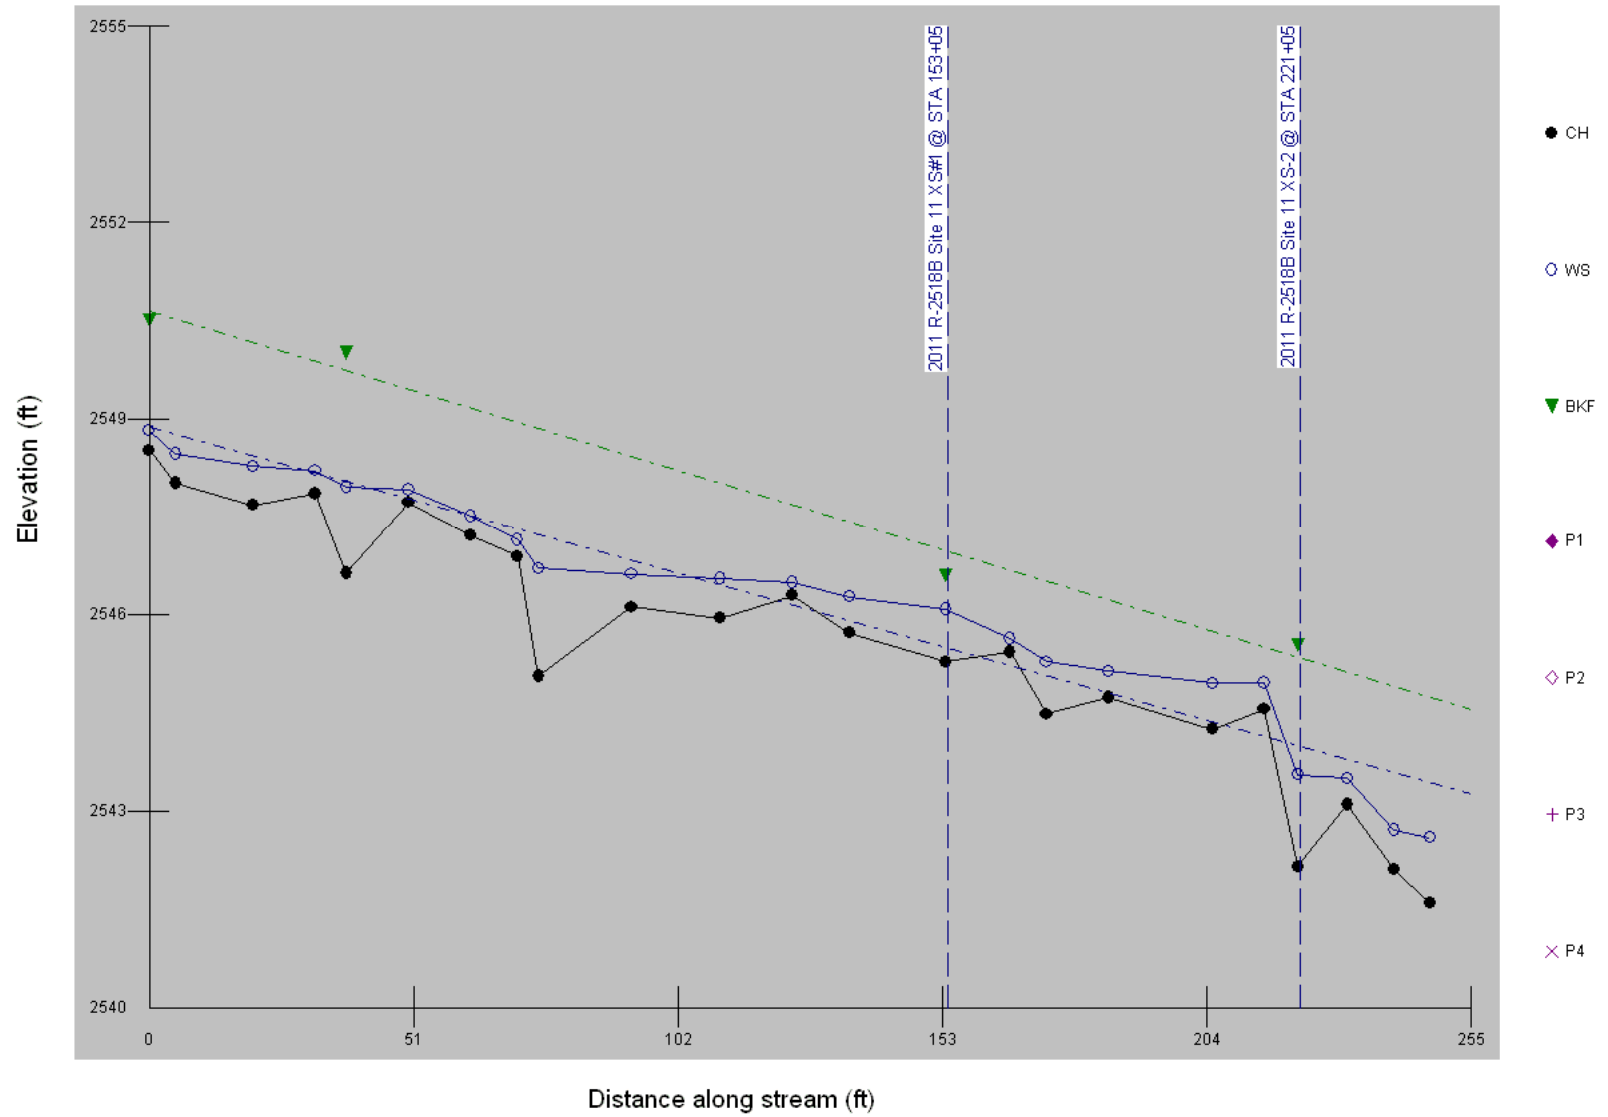
2011 R-2518B Site11 Profile

Based on comparisons of the As-Built to the monitoring data, all of the cross sections appear stable with little or no active bank erosion. Graphs of the cross sections are presented in Appendix A. Future survey data will vary depending on actual location of rod placement and alignment; however, this information should remain similar in appearance. The longitudinal profile showed that the channel was stable for the 2011 monitoring evaluation. Pebble counts were not required per the permit conditions and therefore were not completed.
